Prediction of Remaining Service Life of the Yogyakarta-Kaliurang Provincial Road Section of Sleman Regency using the PCI Method

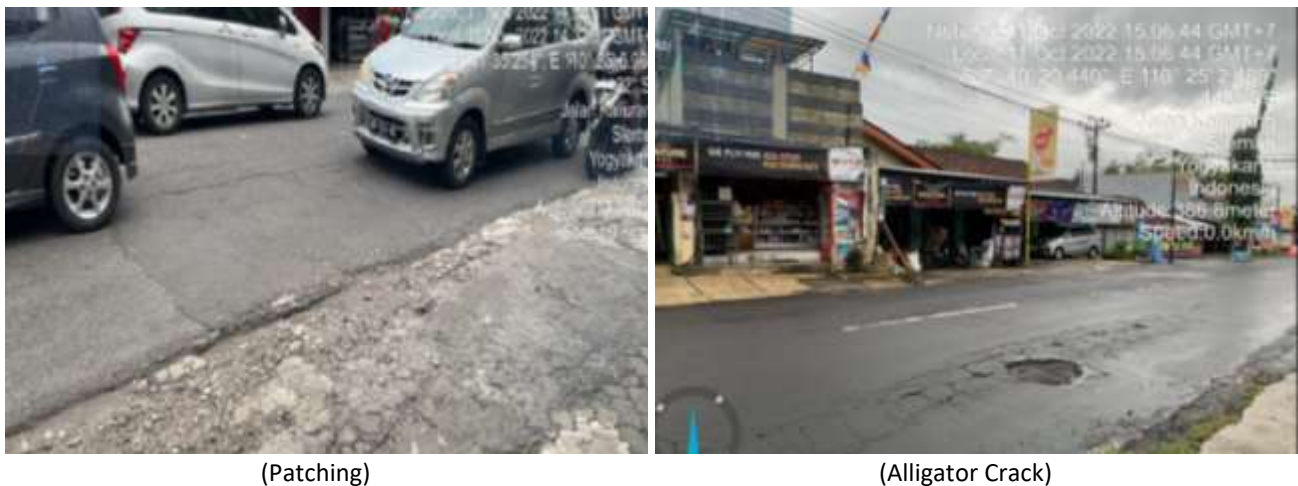
The dominant distress occurred on the roads 6 km long Yogyakarta-Kaliurang Provincial Road Section were patching (36.31%) and alligator crack distress (12.30%) (Table 3).

Patching is dealing with damage caused by the large number of heavy vehicles passing by, especially trucks carrying sand, as reported by Harian Jogja [23]. Patching type damage causes discomfort for road users. An example of an image of patching damage and alligator cracks can be seen in Figure 6.

Fig. 6. Patching and alligator crack distress type

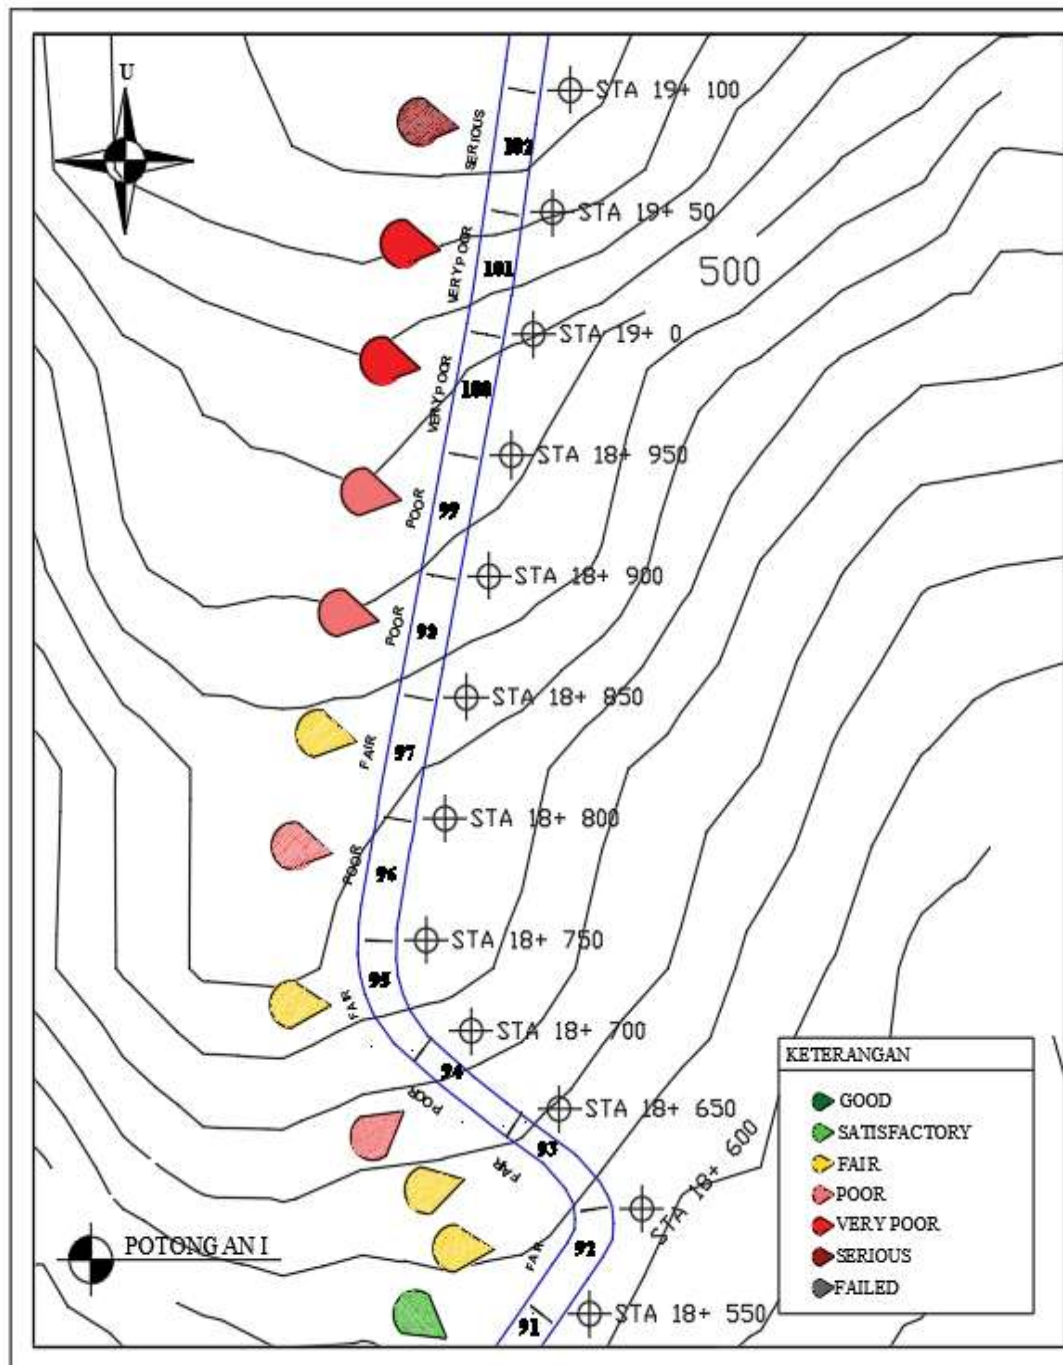
The PCI was attained after obtaining the CDV using Eq. (3). An example of PCI calculation in segment 102 with the highest CDV was 12% (100-CDV). Hence, in segment 102, a PCI of 12% was obtained, signifying a serious pavement damage condition. Table 5 lists the PCI from segments 1 to 120, acquiring an average PCI of 59.4%, implying a fair pavement damage condition.

In short, the pavement with the lowest value was in segment 102, falling within a serious condition, as portrayed in Figure 14.

Fig. 14. Cutout layout in segment 102
