A Novel Investigation on Microstructural Analysis of a Rupture GRE Composite Pipe for Underground Fire Water System

GRE pipe; rupture; microanalysis

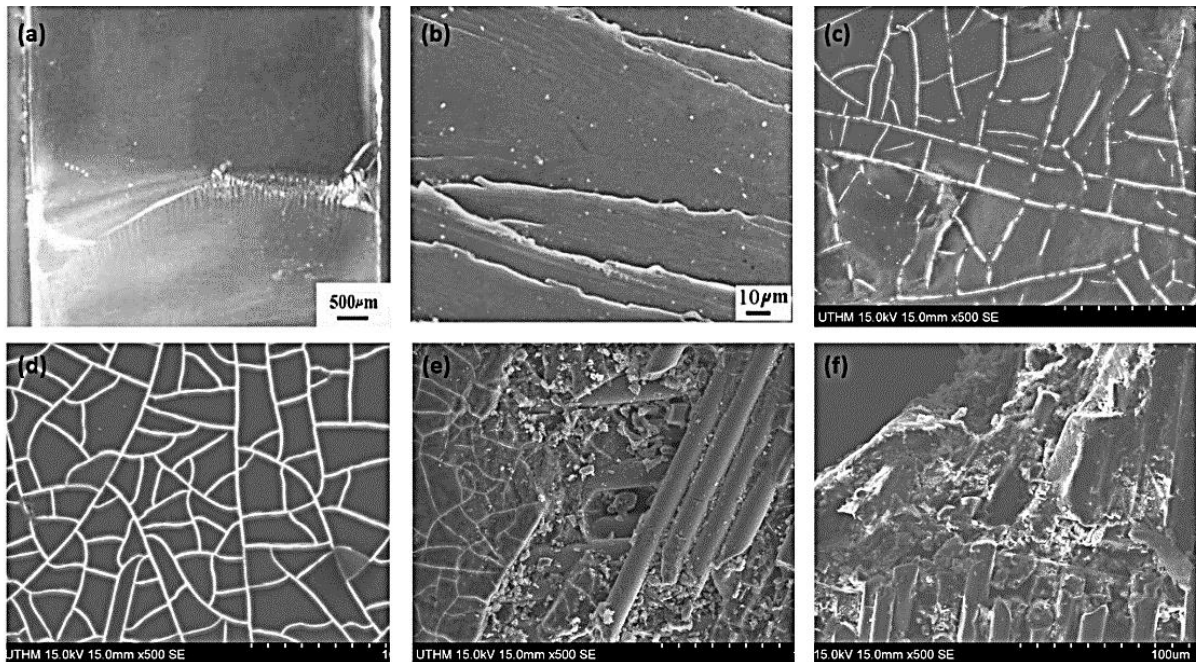
To understand the impact of foreign materials on structure and integrity, Scanning Electron Microstructure (SEM) analysis is essential. Figure 5(a) and Figure 5(b) provide baseline micrographs of neat epoxy resin with fibers, captured from a fractured surface. In Figure 5, an in-depth exploration of the microstructure focuses on the outer layer at varying distances from the failure point.

Microcracks are observed, with Figure 5(c) showing fewer microcracks than Figure 5(d), indicating structural degradation in the GRE pipe.

Fig. 5. (a) Optical micrographs of neat GRE [22], (b) SEM micrographs of neat GRE [22], (c) Undamaged further to failure, (d) Damaged further to failure, (e) Damaged close to failure, and (f) Damaged at the failure

Further examination of Figure 5(c) reveals an optimal condition farthest from failure, while Figure 5(d) showcases the damaged area, yet it is still farther from complete failure. Both figures illustrate the presence of microcracks on the surface. Additionally, matrix degradation is observed in the form of flake formation. Fiber damage is also noted, indicated by changes in fiber circularity, as shown in Figure 5(e) and Figure 5(f). Despite an initial inspection at X3000 magnification showing no obvious defects in the baseline micrographs, compare with magnification of X500 already exposes microcracks, offering insights into the GRE pipe's internal structure and defect progression.

- Figure 5(c): Undamaged furthest to failure (presence of microcracks observed)
- Figure 5(d): Damaged furthest to failure (more microcracks observed compared to Figure 5(c))
- Figure 5(e): Damaged closer to failure (presence of microcracks and fiber damage)
- Figure 5(f): Damaged at the failure point (presence of microcracks, fiber damage, and matrix degradation)
- Microcracks are visible in Figure 6(b) at the point of adhesive failure.
- Adhesive failure (Figure 6) was observed at the point of fiber-matrix bonding.
- Whitening observed during tensile testing (Figure 7) indicates early failure and potential delamination.
- SEM analysis of tested pipes revealed fiber breakage, delamination, and pull-out failures

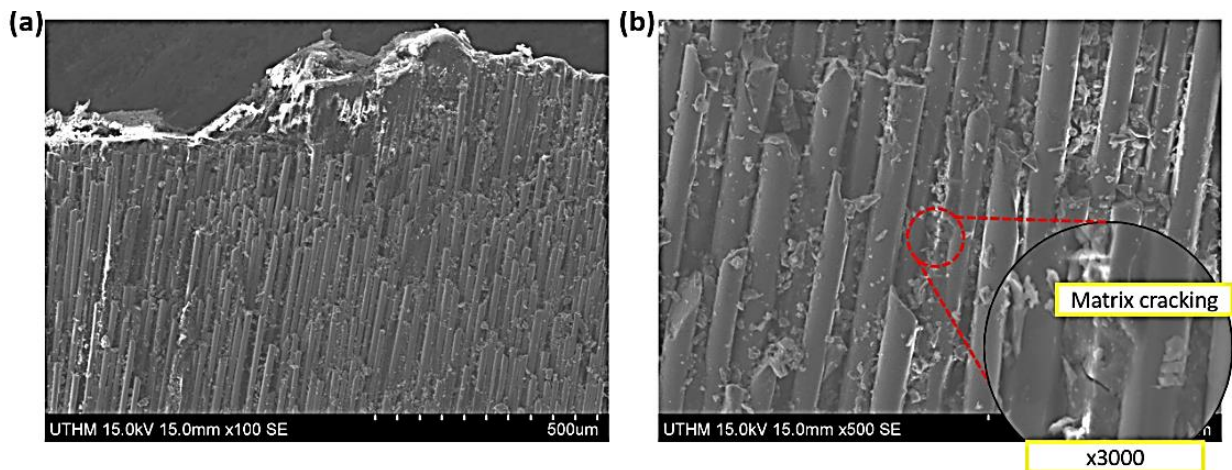
Examining the fiber at point C mentioned, Figure 3 shows an adhesive failure mode, mainly seen in Figure 6(a). Adhesive failure happens when the adhesive material used is weaker than the materials being bonded. Microcracks, visible at these points in Figure 6(b), can propagate and eventually lead to larger matrix cracks, commonly observed in SEM images.

Fig. 6. (a) Point C damaged area, and (b) Matrix cracking

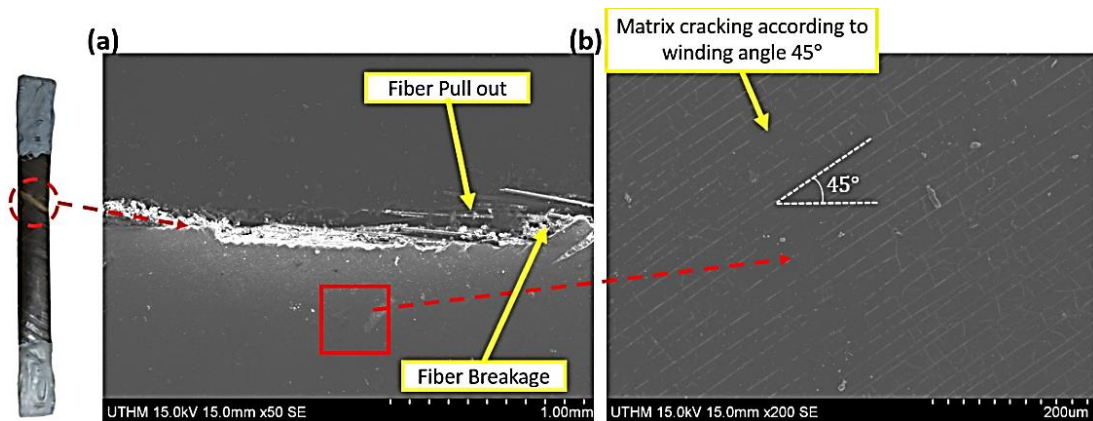
Microcracks in the matrix can be caused by factors like localized stress concentrations, material defects, and environmental conditions [33]. In Figure 7, as the applied tensile load increases during testing, these microcracks can spread and lead to matrix cracking. This process ultimately impacts the mechanical properties and structural integrity of the composite material. It's worth noting that all the tensile specimens showed the same whitening phenomenon.

Fig. 7. (a) Failure modes on tensile sample, and (b) SEM whitening area tensile failure

The whitening observed on the surface, indicating early failure in the filament winding direction, has been identified by Hawa *et al.*, [10]. This whitening results from debonding and delamination processes within the multi-layer bonded structure of the pipe. Structural degradation leads to radial expansion due to hoop stress, exposing the interlayer structure to shear stress parallel to the fiber winding direction [5,34]. Radial cracks are formed and propagate based on the fiber winding angle in the layer stacking [35]. SEM analysis on the tested pipes revealed more intense observations of fiber breakage failures, delamination, and pull-out failures. Additionally, the glass fibers exhibit brittle failure behavior with a net fracture along the ply [17]. Identifying whitening during tensile testing can be a valuable tool for early detection of potential failure in the filament winding direction, allowing for preventative maintenance or pipe replacement before catastrophic failure. It's essential to determine the appropriate winding angle for both hoop and longitudinal strain [24].

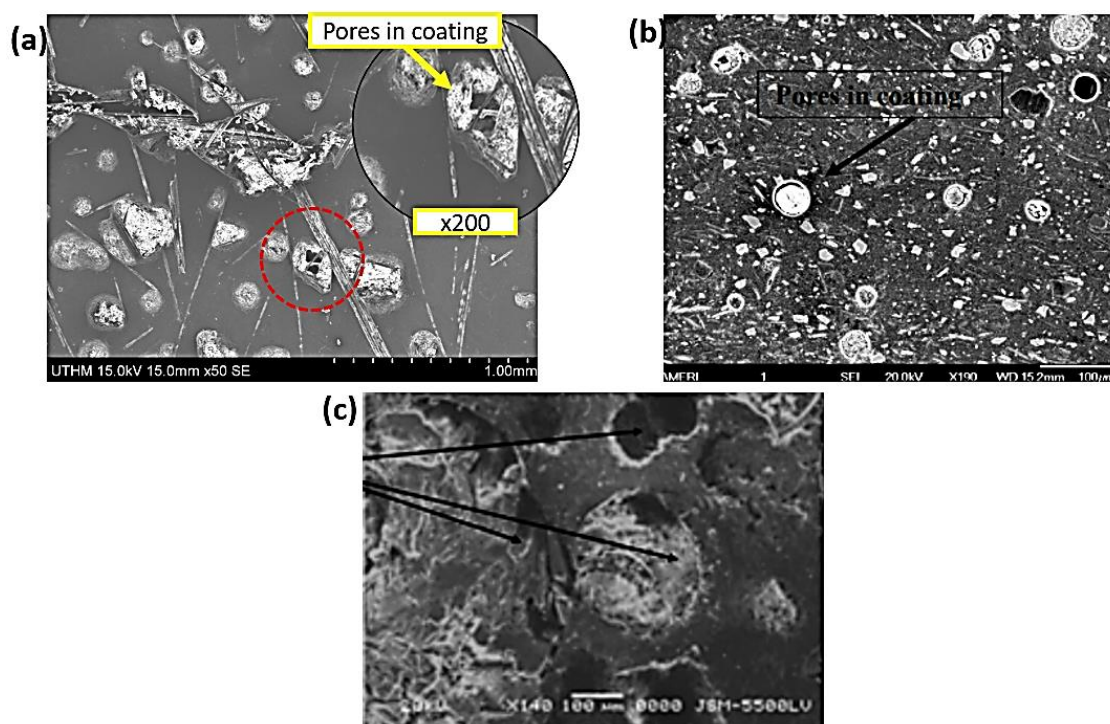
Figure 8 shows pores on the inner surface of a pipe liner, whether metallic or polymer, acting as a barrier against the inner fluid [25]. The current design assumes that the inner layer, serving as a fluid barrier, remains unaffected by potential matrix breaking in the outer pipe layer [8]. Pore formation in protective coatings can result from various factors, including soil conditions like

Fig. 8. (a) Pores occurred on the surface of liner; (b) Hybrid epoxy external coating pore [19]; (c) Deep pores in the external matrix [26]

- Figure 8 shows pores on the inner surface of a pipe liner, regardless of whether it's metallic or polymeric.

- Unlike previous studies, this research identified pores on the inner surface, potential due to burial conditions (Figure 8(b), Figure 8(c)).
- After mechanical testing observation
- Delamination cracks (Figure 9) were observed due to the applied tensile load exceeding the material's interlaminar strength.
- Weak bonding between fibers and the matrix can cause fiber pullout (Figure 9(b)) and reduce the composite's strength.
- SEM images (Figure 10) show fiber pull-out, debonding, and detachment due to weak bonding, voids, or moisture presence.

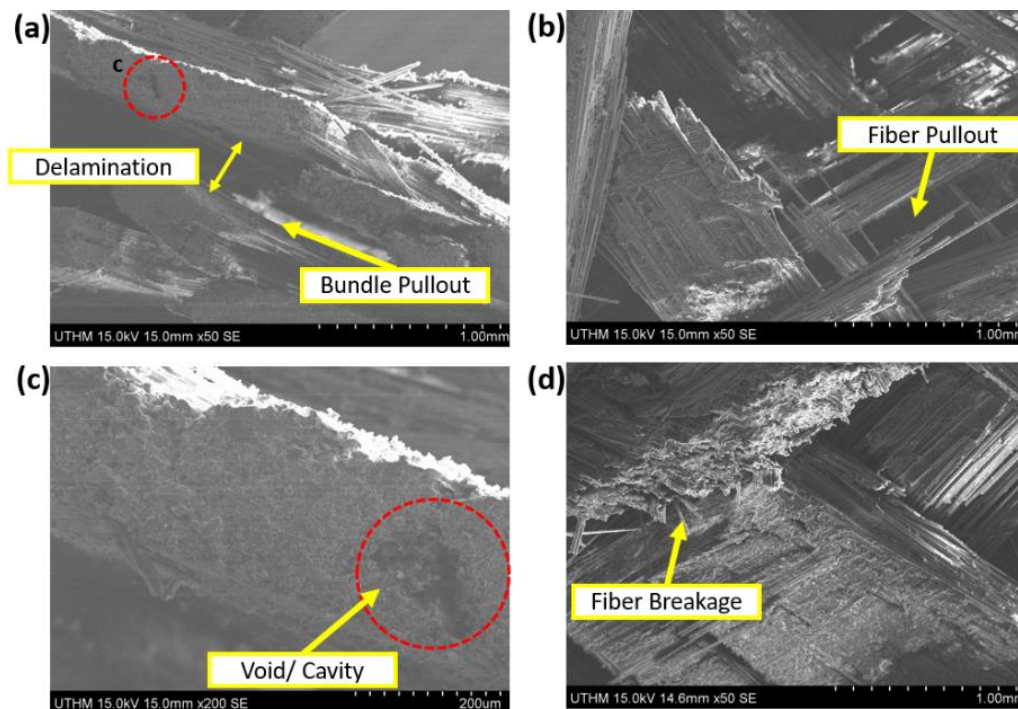
Figure 9 shows a flexural failure with delamination cracks in the structural layer, as seen in the cross-sectional view in Figure 9(a). The study indicates that delamination in the GRE pipe under investigation is due to the applied tensile load surpassing the material's interlaminar strength [27].

Fig. 9. (a) Cross section SEM; (b) Outer surface SEM; (c) Magnification cross section SEM; (d) Inner surface SEM

Localized porosity and insufficient resin filling lead to the formation of cavities and cracks at the fiber/resin contact [5]. At the failure section, Figure 9(c), the glass fiber layer displays brittle fracture characteristics, with pulled-out fibers creating holes. The fibers, once pulled out, show minimal resin covering, indicating a weak bond with the resin [5]. Failure primarily occurs at the fiber-resin interface, resulting in layer separation and a rough surface.

In Figure 9(b), compression results in a failure mode characterized by fiber pullout, indicating a weak bond between fibers and the matrix. This impacts the composite material's mechanical properties by reducing stiffness and strength [27]. Fiber pullout can initiate further damage, as separated fibers create stress concentrations, contributing to crack propagation.

In Figure 9(d), tension results in the failure mode of fiber breakage, characterized by complete fracture of fibers due to the applied tensile load. In the GRE pipe during the tensile test, fiber breakage occurs when the load exceeds the ultimate strength of the fibers [27].

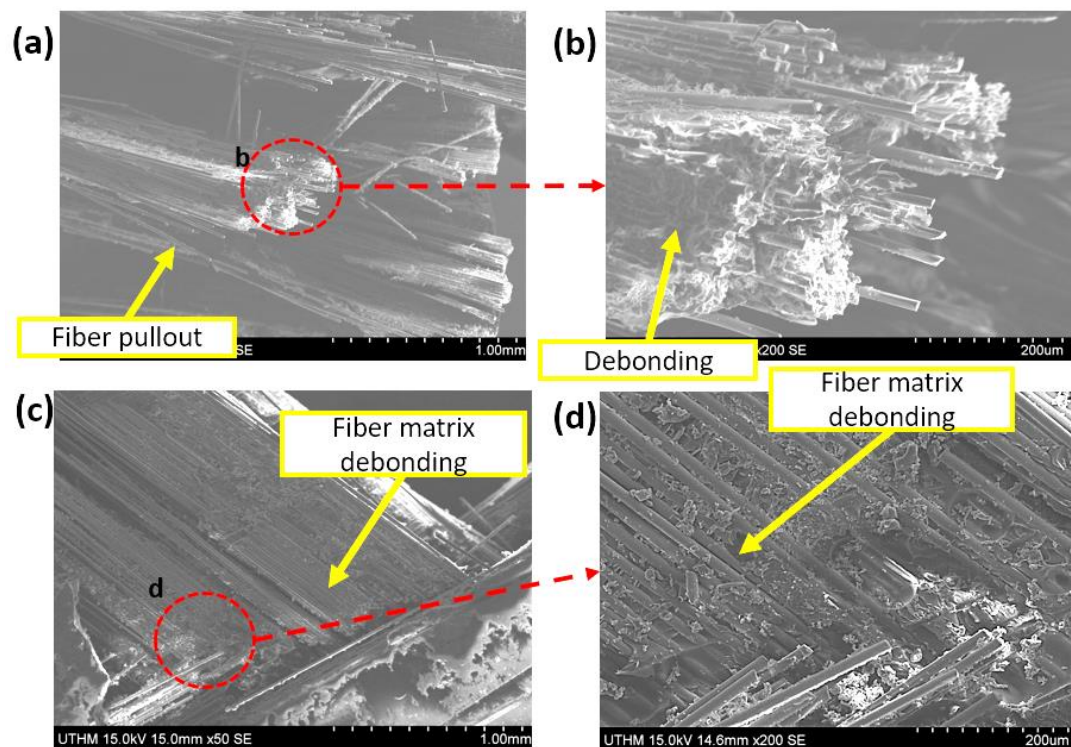
Figure 10 shows the results of an impact test. In Figure 10(a), fiber pull-out is observed, where the fiber separates from the matrix without breaking. This can happen due to weak bonding or the presence of voids or defects in the composite structure, as seen in Figure 10(b). Figure 10(c) depicts fiber/matrix debonding, where the fiber separates from the matrix due to bonding interface failure. This can occur due to inadequate adhesive bonding or the presence of contaminants or defects at the bonding interface. Figure 10(c) shows fibers detaching from the matrix due to moisture presence, caused by moisture-induced porosity and voids, leading to reduced joint strength [28].

Fig. 10. (a) Cross section SEM; (b) Magnification cross section; (c) Outer surface SEM; (d) Magnification outer surface
