A Novel Investigation on Microstructural Analysis of a Rupture GRE Composite Pipe for Underground Fire Water System

GRE pipe; rupture; microanalysis

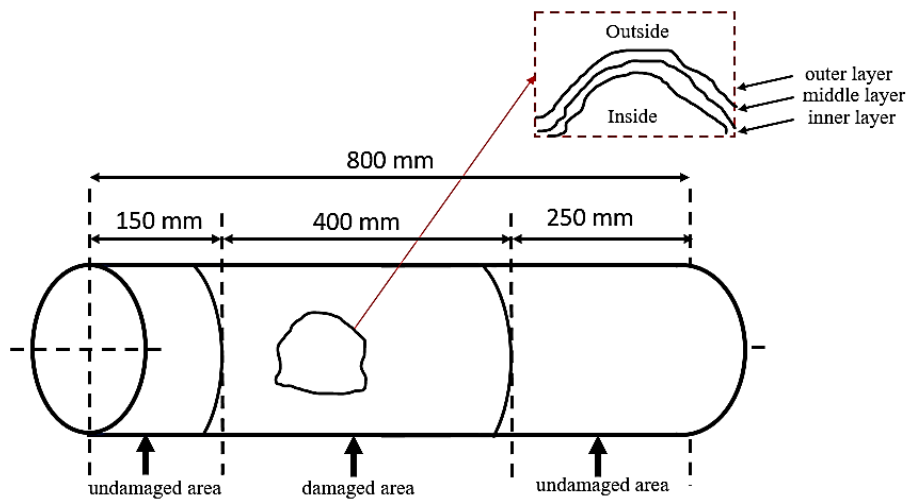
Fig. 2. Illustration area divided on the pipe

In this study, a sample pipe from the Bonstrand 2420-FM series, designated as 1N103BQ confirming to ISO14692 standards, was used. The GRE pipe, with a design pressure of 18.4 Bar, design temperature of 75°C, epoxy resin construction, adhesive-bonded joint, 5mm thickness, 800mm length, and 150mm nominal diameter, meets industry standards with tailored specifications for durability and corrosion resistance. The pipe can withstand a maximum pressure of 16 Barg and operates within a temperature range of up to 75°C. An adhesive-bonded joint securely connects its components for structural integrity. The GRE pipe subjected to the study was divided into parts and set in the back, right, and left directions, as shown in Figure 2.

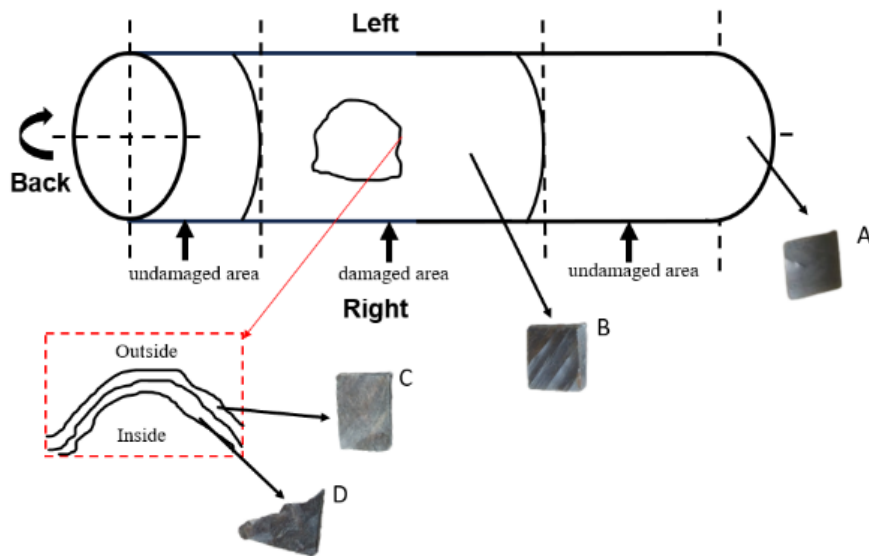
Fig. 3. Illustration specimens taken from the pipe

Specimens measuring 10 mm x 10 mm x 5 mm, matching the pipe's average thickness of 5 mm, were extracted for analysis. They were labeled A (furthest in the undamaged area), B (further in the damaged area), C (closer in the damaged area), and D (at the damaged area), as illustrated in Figure 3. The samples selected for analysis were derived from the mechanical tests with the highest values, including tensile, impact, and flexural tests, aiming to understand the failure mechanisms and their implications.
